TURKEY CREEK RANCH
(5EP836)
FORT CARSON, COLORADO

Karin M. Roberts
and
James Schneck

National Park Service
Midwest Archeological Center
Lincoln, Nebraska

September 1998

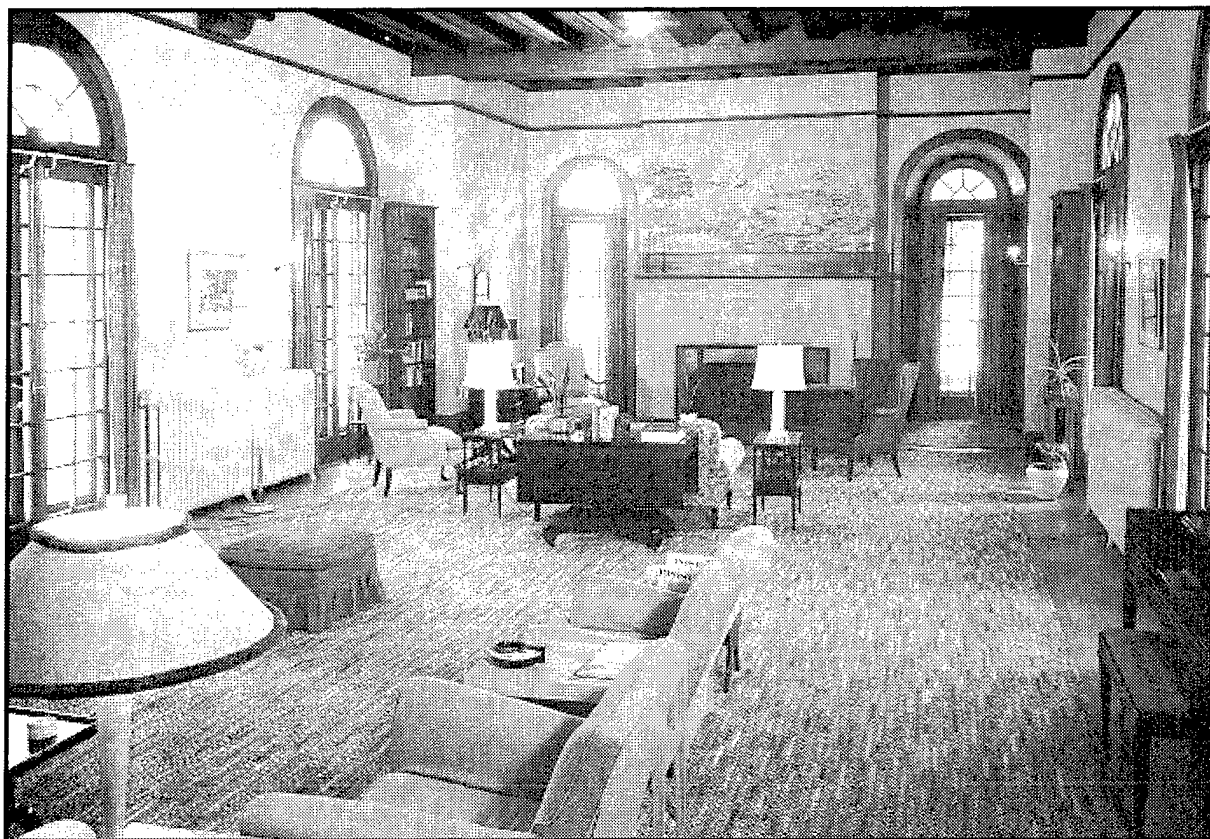
Figure III.14 5EP836. Building 10000, Main House. Living Room. Note mural on north wall above fire place, dark window trim and ceiling, and light fixtures. 1957 photograph by Stewarts Photographers, Colorado Springs, Colorado. On file at Local History, Pikes Peak Library District, Colorado Springs, Colorado.

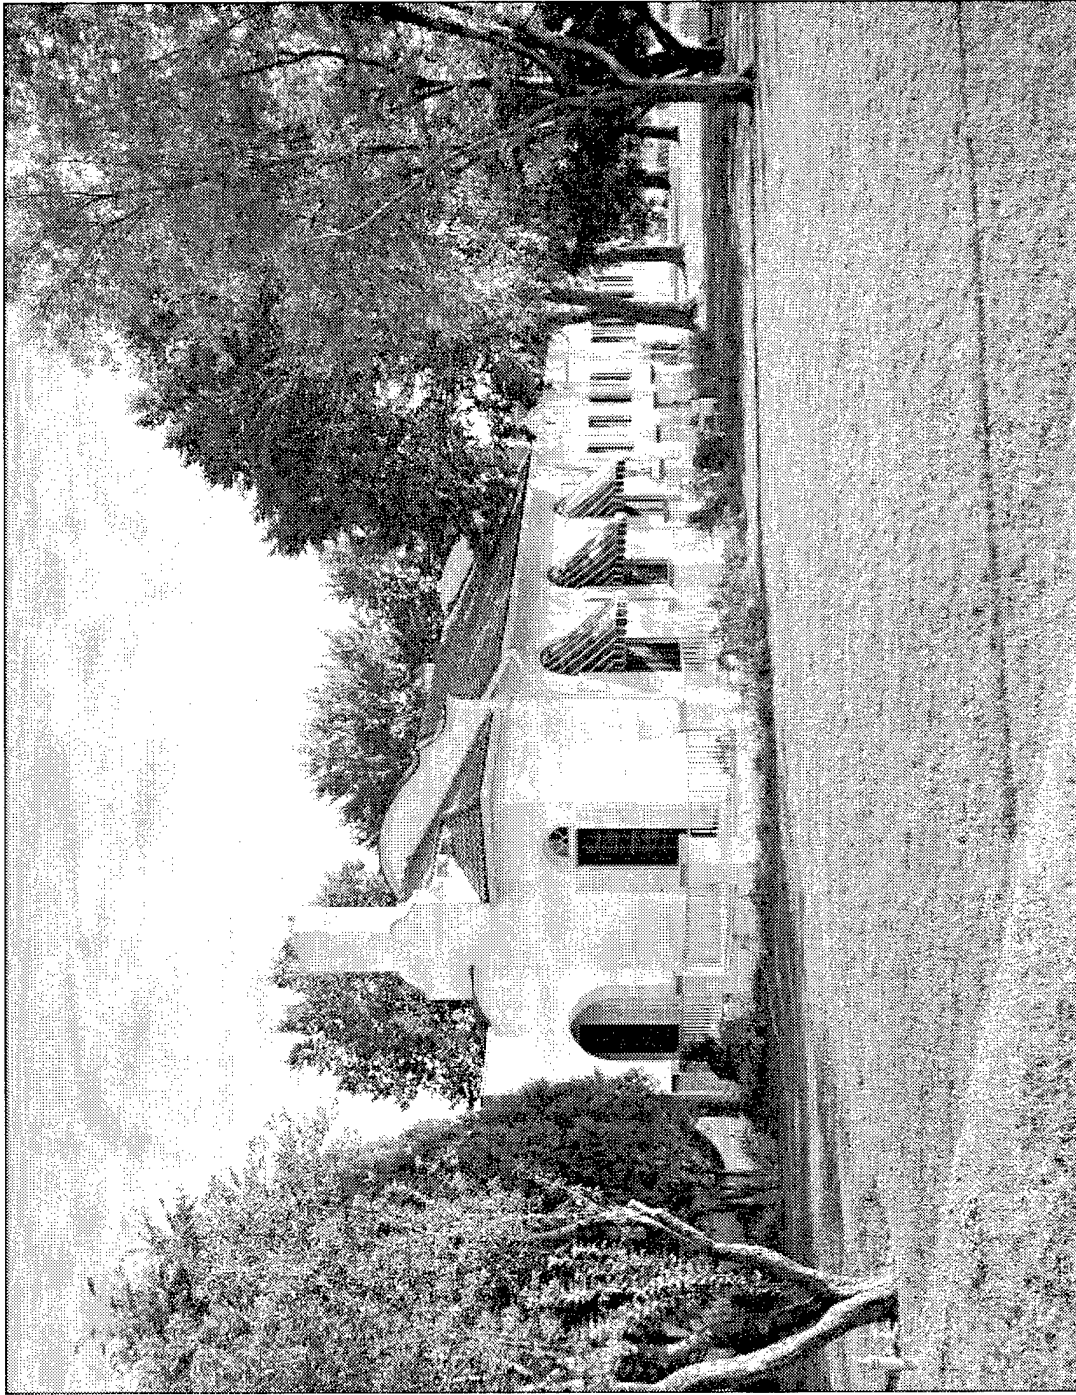
Figure III.17 5EP836. Building 10000, Main House. Note the awnings and shutters, and the lack of a west entrance to the servants' wing. Pre-1957 photograph by Stewarts Photography. On file at Local History, Pikes Peak Library District, Colorado Springs, Colorado.

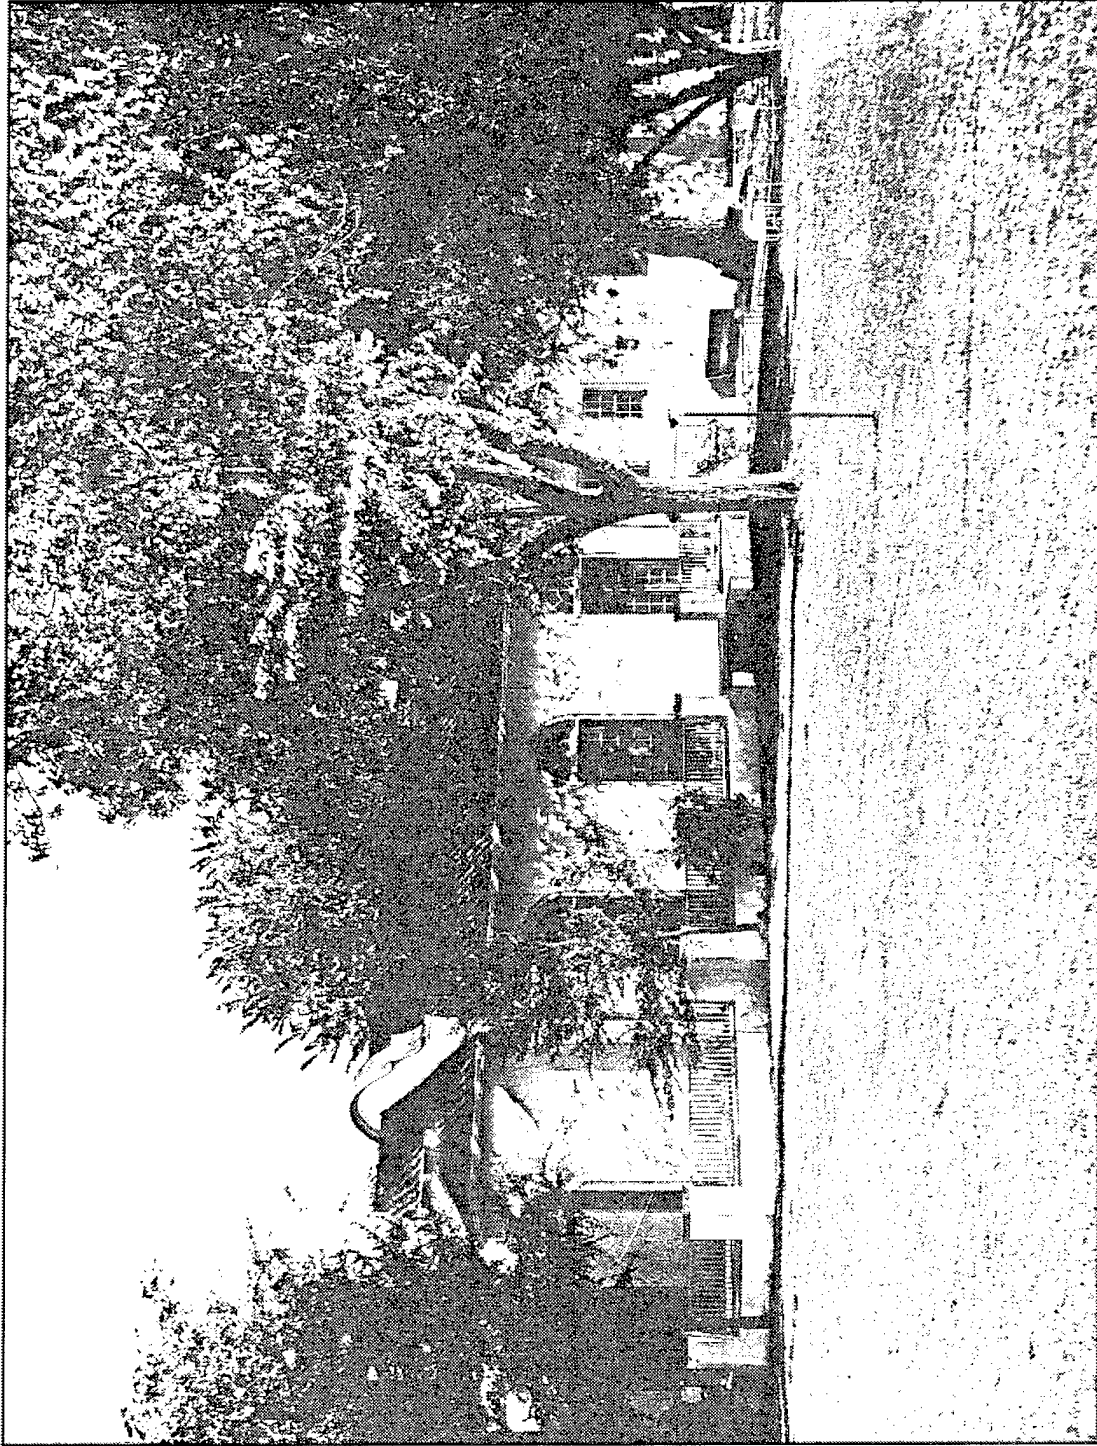
On the exterior, the rehabilitation included the installation of a new handicapped ramp on the building's west side. This entrance was not original, but was installed sometime before 1956 (Figure III.16). Rehabilitation also included the replacement of window and door screens with new aluminum storm windows and doors. The exterior walls were covered with a thin layer of concrete stucco, and painted white with orange trim.

Figure III.18 5EP836. Building 10000, Main House. West entrance has been added to the servants' wing, awnings and shutters have been removed. 1957 photograph by Stewarts Photography. On file at Local History, Pikes Peak Library District, Colorado Springs, Colorado.

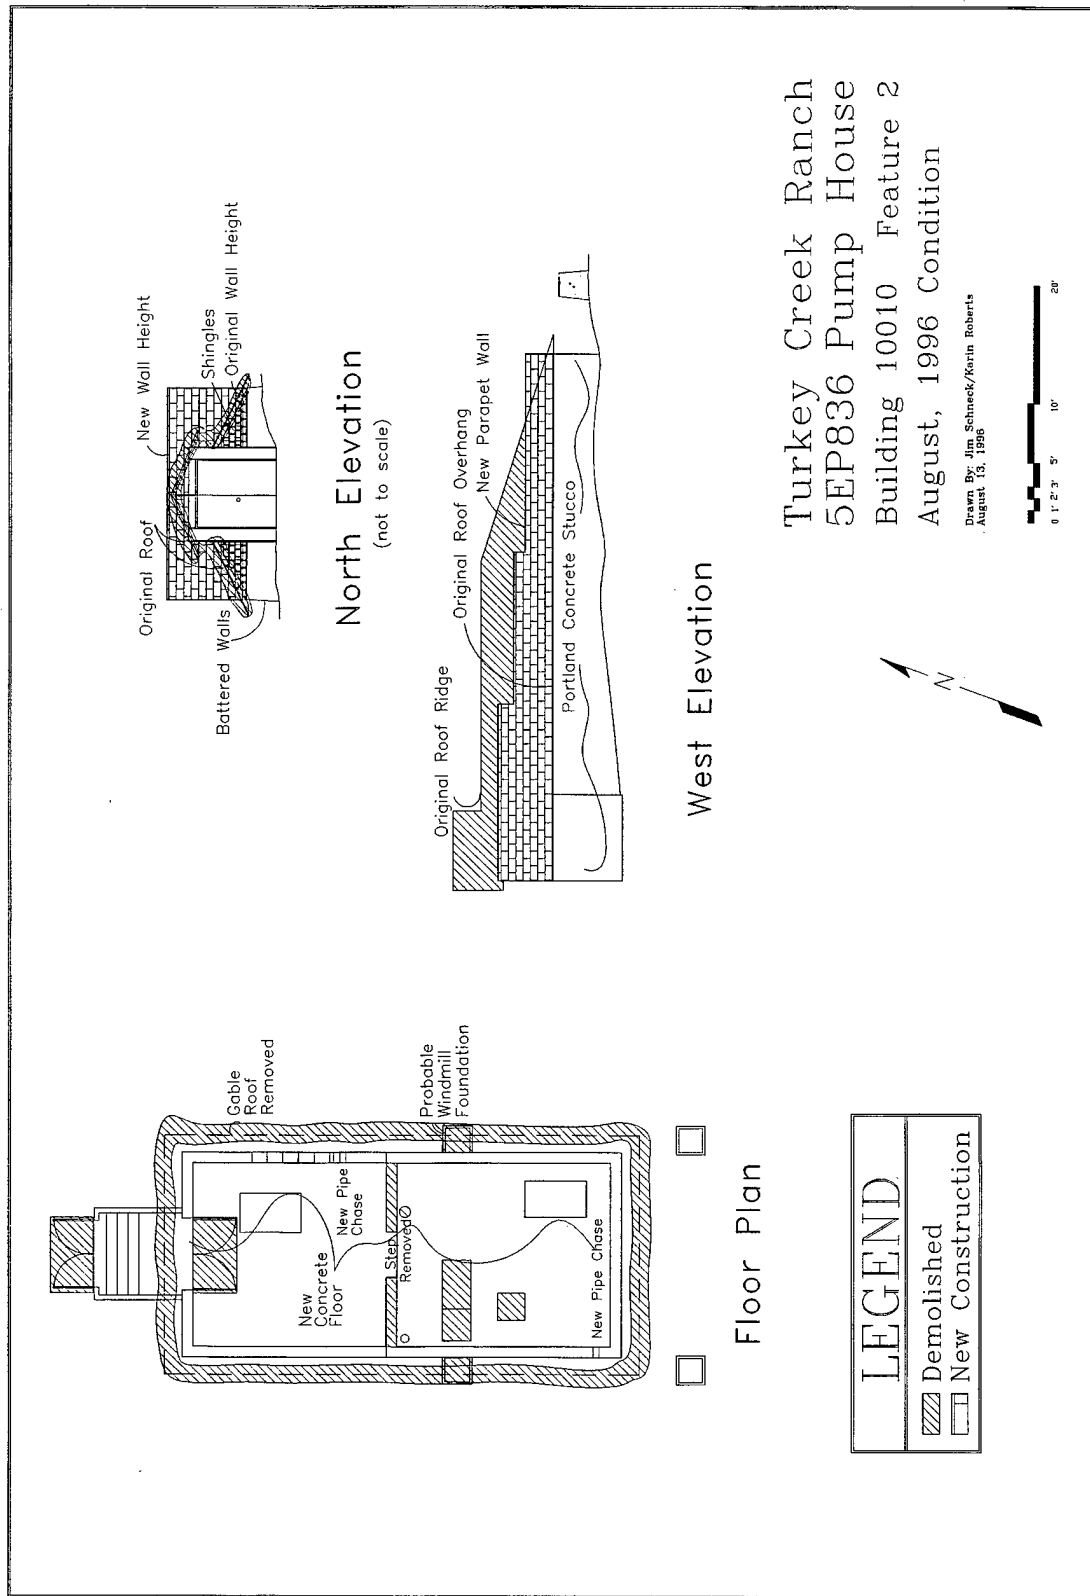
Figure III.62 5EP836. Building 10010, Pump House. August, 1996 Condition. AutoCAD drawing. Midwest Archeological Center.

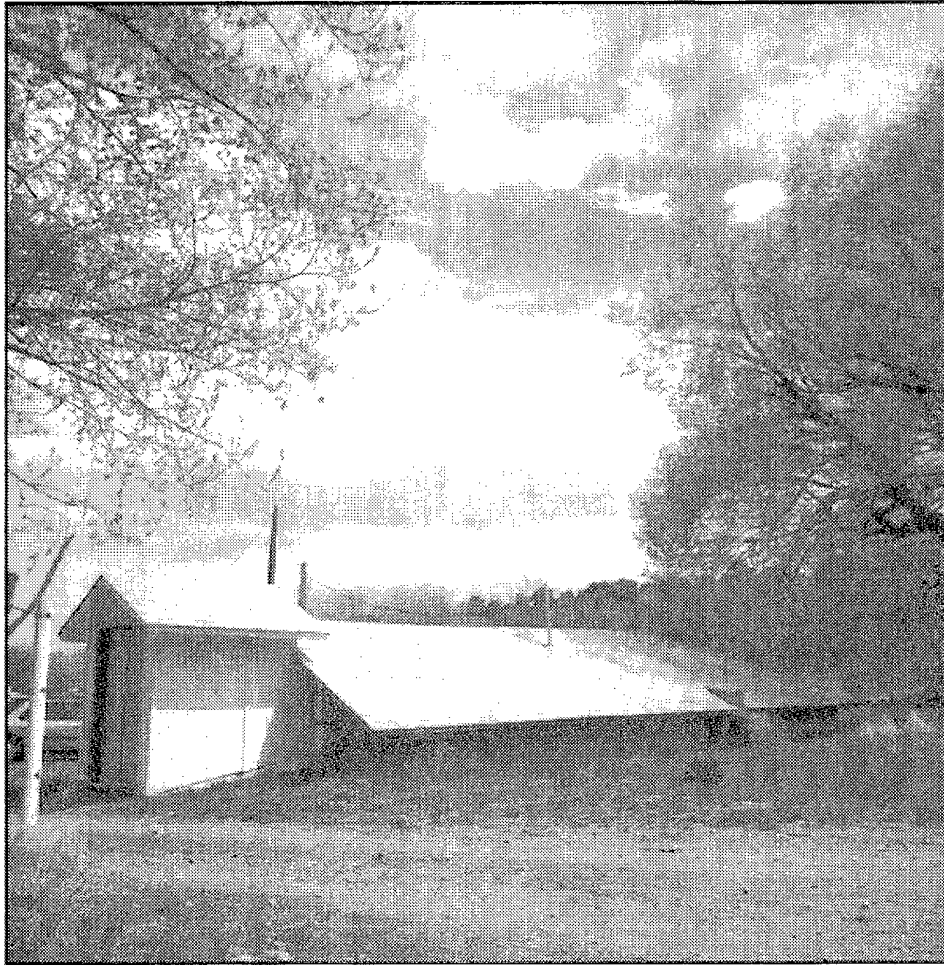
Figure III.63 5EP836. Building 10010, Pump House. 3/4 view of north and west sides of root cellar. Concrete pier protrudes through overhung eave. Roll TCR-4, Exposure 5.

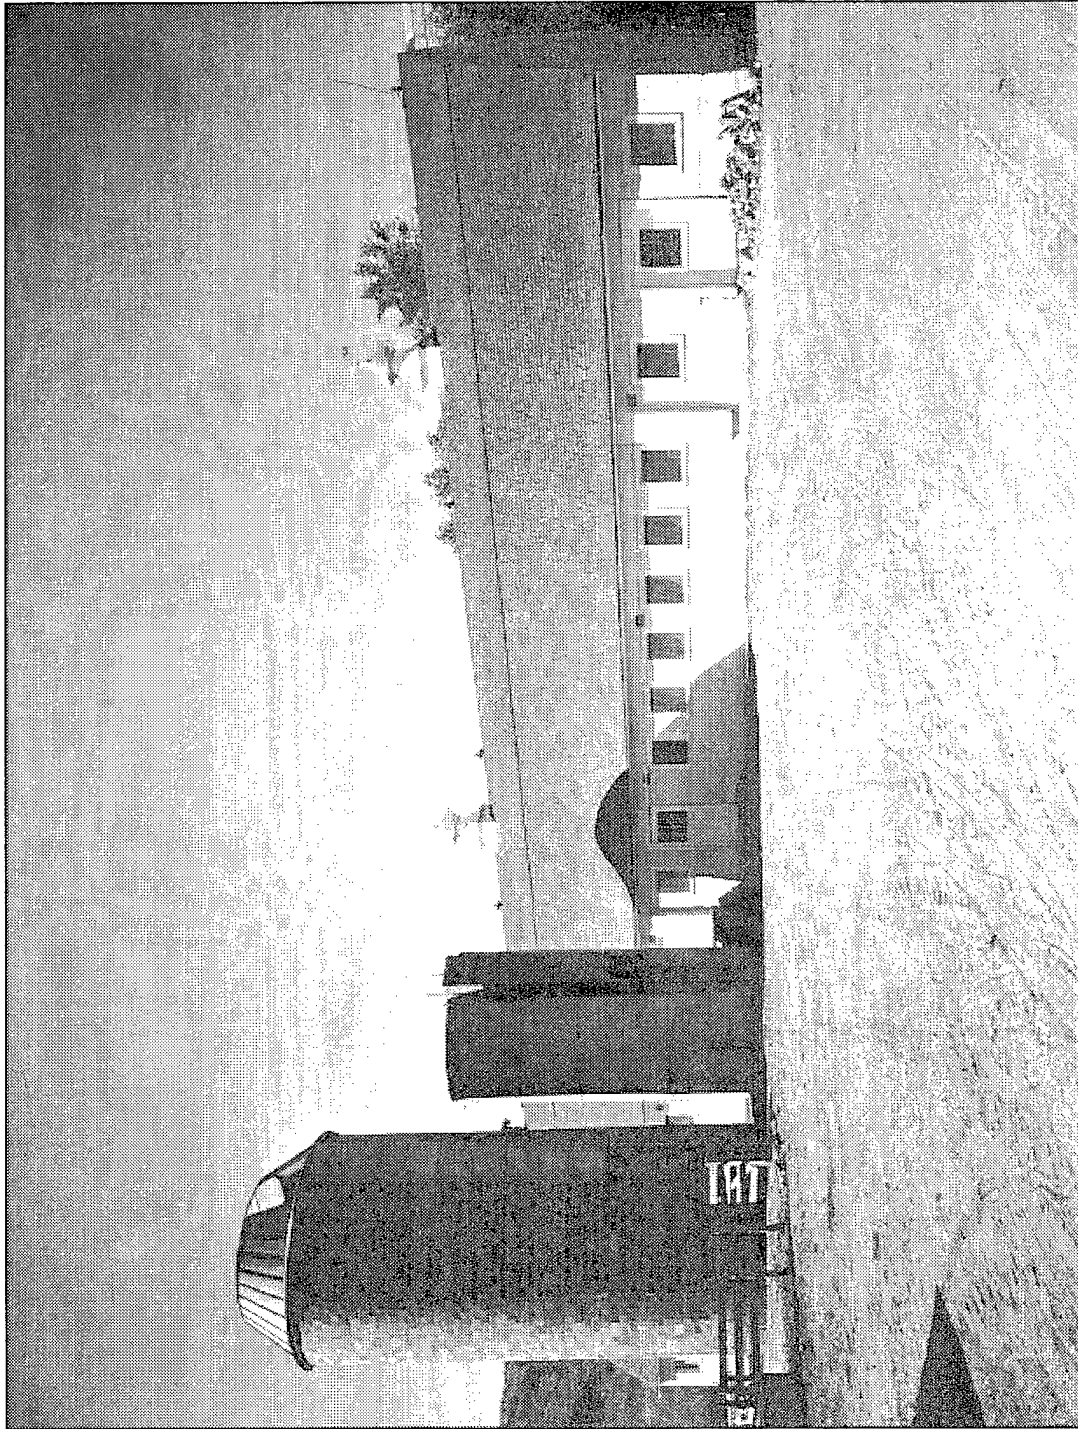
Figure III.73 5EP836. East face of Color Guard Barn 10014. Note ventilators on roof, former silos, and sealed door on north end of building. 1957 photograph by Stewarts Photographers, Colorado Springs, Colorado. On file at Local History, Pikes Peak Library District, Colorado Springs, Colorado.
